Seagrass Prop Scarring

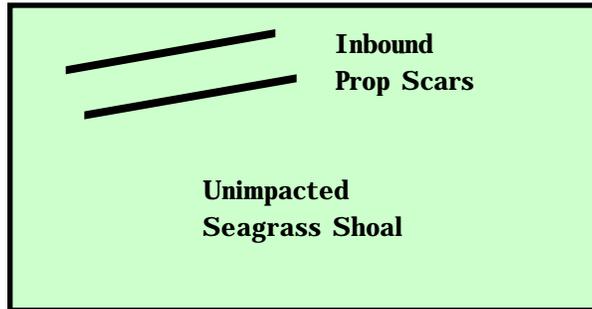
These diagrams were created to document the sequence of events that occurred when a twin-engine boat grounded on a seagrass flat within the Florida Keys National Marine Sanctuary. First, the boat propellers dredged parallel prop scars across the seagrass flat (above left).

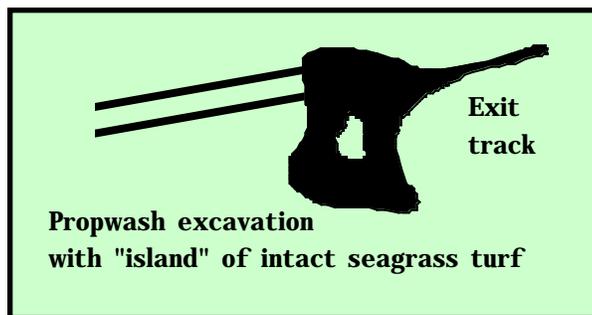
Second, when the boat operator attempted to "power off" using the engines, a barren sandy crater known as a "blow-hole" was created (above). An exit track was also dredged leaving behind an intact "island" of seagrass turf and a propwash blow-hole

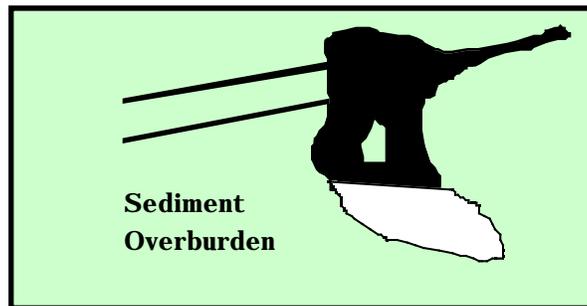
Finally, the propwash excavation by the boat engines caused sediment to become deposited behind the boat on top of unimpacted seagrass (above). Blow-out scars, entrance and exit tracks, and sediment deposits are features of grassbeds that have been impacted by boaters.
